The Effect of Rust Removal Agent on Bond Strength of Reinforcing Steel Bars.

The Effect of Rust Removal Agent on Bond Strength of Reinforcing Steel Bars

Associate professor, Housing & Building Research Center, Cairo, Egypt

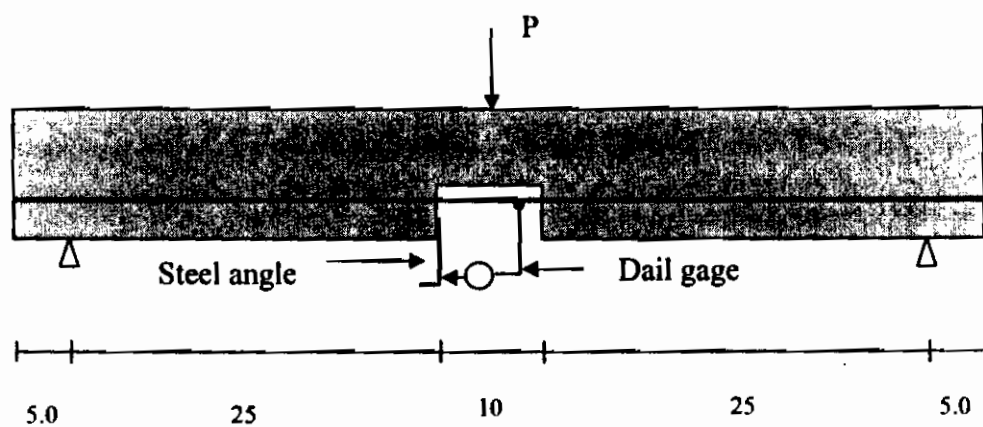
Fig. (1) Typical beam specimen for bond test

Y= high tensile steel (36/52), Dimensions in cms
 Cross section of the beam 10×10 cm

To achieve the objective of this research, the test program was divided into four phases. The first phase is weighing the group of different diameters of corroded steel bars before and after brushing the rust converter to show if there is a loss or increase in the weight and to inspect the steel bars surface after brushing the rust converter. The second phase is to immerse steel bars brushed with rust converter and others without rust converter in saturated sodium chloride solution, at ambient temperature for two weeks. The concentration of the salts in solution was 30000 p.p.m. Wetting / drying cycles were repeated day after day for two weeks and visual appearance was monitored. The third phase is the pullout test to determine the bond strength. A total of 30 pullout specimens were tested in ten groups. Each group consists of three specimens (15×30 cm cylinder) with an embedded deformed steel bar of 10 mm diameter at the center of the specimens. The details of the studied parameters are shown in Table (1). The fourth phase consists of five group. The specimen used in this phase is shown in Fig. (1), which illustrates the configuration and dimensions of the test specimen. The specimen is a flexural beam separated in the middle with the reinforcing bar (10 mm diameter) crossing the gap. This test is preferred over a direct pullout test because it is more realistic and simulates the actual condition in beams or slabs. The details of the parameters of this phase are shown in Table (2).
