Performance of UHP-SHCC Material in Repairing RC Beams Subjected to Torsion.

Atta, A.; Etman, E.; and Kassem, Nesreen (2021) "Performance of UHP-SHCC Material in Repairing RC Beams Subjected to Torsion.," *Mansoura Engineering Journal*: Vol. 37 : Iss. 3 , Article 6.
Available at: <https://doi.org/10.21608/bfemu.2021.156966>

PERFORMANCE OF UHP-SHCC MATERIAL IN REPAIRING RC BEAMS SUBJECTED TO TORSION

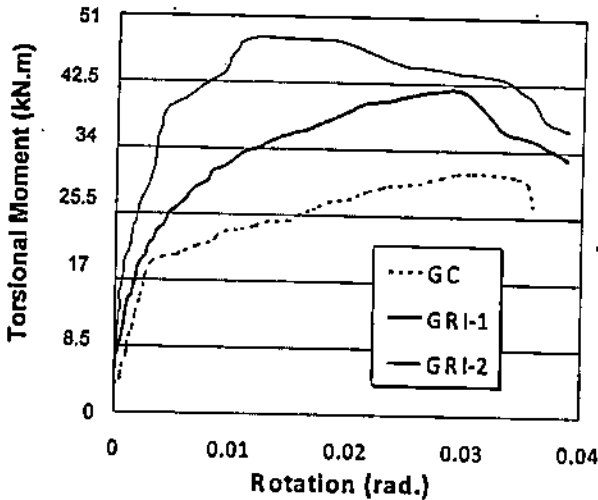
Fig. 6 Rotation results for tested specimens.

For the control specimen, sudden excessive torsional rotation at ultimate load was noted. Specimens repaired using the UHP-SHCC material indicated had reduced torsional rotation values at early load stages compared to the control specimen. Specimens GRI-2 and GRII-2

with internal embedded reinforcement inside UHP-SHCC layer had greater torsional stiffness after the failure load compared to specimens GRI-1 and GRII-1 with UHP-SHCC layer only as shown in Fig. 6 and 7.
