## Acquiring Data for Highway Maintenance Using Fixed Terrestrial 3d Laser Scanning System.

Alawi, Mohammad (2020) "Acquiring Data for Highway Maintenance Using Fixed Terrestrial 3d Laser Scanning System.," *Mansoura Engineering Journal*: Vol. 41 : Iss. 1 , Article 10.

Dr. Mohammad H. Alawi

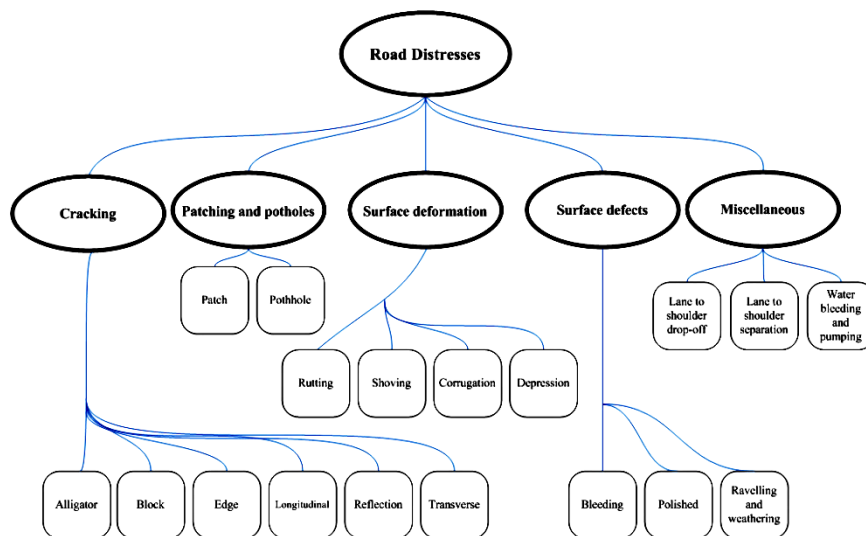
Figure 1 S.H.R.P Asphalt concrete surfaced pavement distress types

In this paper road flexible pavement distresses are classified using survey instruments, information about these distresses will be summarized. Five major categories of flexible pavement road distresses are considered in this research [1, 2, 9], as shown in Fig.1.

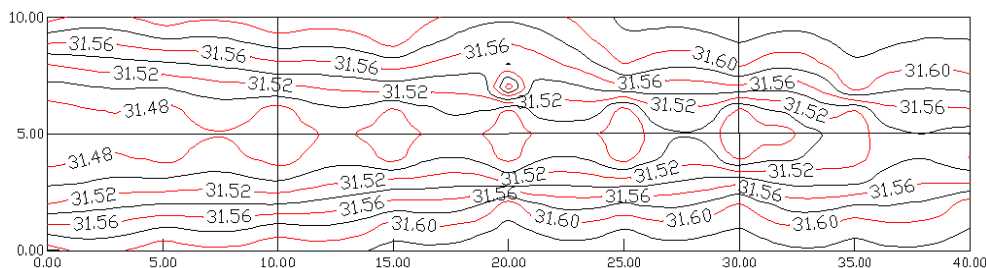
Figure 2. Contour map for the surface road

A symmetrical kriging algorithm [4] was used to interpolate across the road surface to obtain the grid points. After generating the grids file, contours map with 2 cm interval, and longitudinal and transverse profiles can be easily obtained for each road of the case study. Examples are shown in Figs. 2, 3 and 4.

To reconstruct the asphalt paving, the road cover of 8 cm depth was cut off and followed by filling the holes and milled ruts with asphalt. For the road shown in Figs. 2, 3 and 4, the volume of necessary materials for road reconstruction are as follows:

- Volume of removed road cover = 1.5 m<sup>3</sup>
- Volume of asphalt = 13.3 m<sup>3</sup>

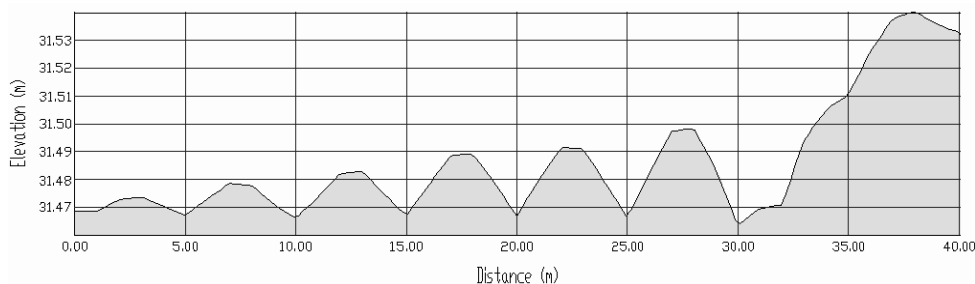
Figure 3. Longitudinal profile for the surface road

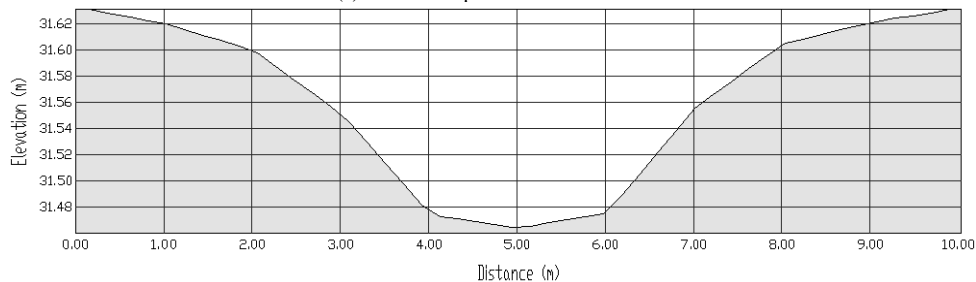
(a) Transverse profile at distance 10

(b) Transverse profile at distance 30

Figure 4. Transverse profiles for the surface road
