Compatibility between Canals Lining Methods and Sites Conditions

Case Study: Al-Khofoog Canal, El-Minia

Tarek Sayed Abu-zeid

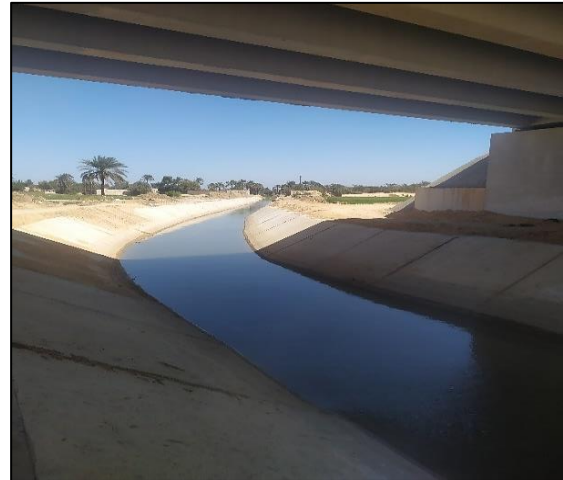
Photo (1): Lining works in the canal

Al-Khofoog canal belongs to west El-Minia Irrigation Engineering Administration in El Minia, Egypt. It takes its share of water on the left bank of Manshyat Al-Dahab canal at km 46.180 and its length is about 6.730 km as shown in figure (1). It serves an area of about 6000 feddans. The proposed length of the rehabilitation and lining process is 3.250 km, starting from the Km 0.0, and rehabilitation works were carried out for a length of 560 meters only, starting from the Km 1.600 by using rubble stone with a thickness of about 50 cm, topped by a layer of plain concrete with a thickness of about 12 cm with side slopes of 3:2 as shown in figure (2), and with the necessary construction joints as shown in photo (1). Photo (2) shows the canal before lining.
