## Upgrading the Inappropriate Visual Character of Urban Context of Historic Sites: A Case Study of the Avenue of Sphinxes in Luxor, Egypt

Gomaa, Ahmed and Al-Sherbiny, Mohamed (2022) "Upgrading the Inappropriate Visual Character of Urban Context of Historic Sites: A Case Study of the Avenue of Sphinxes in Luxor, Egypt," *Mansoura Engineering Journal*: Vol. 47 : Iss. 3 , Article 4.

*Context of historic sites, Urban character, Urban upgrading, Urban regeneration, Avenue of Sphinxes.*

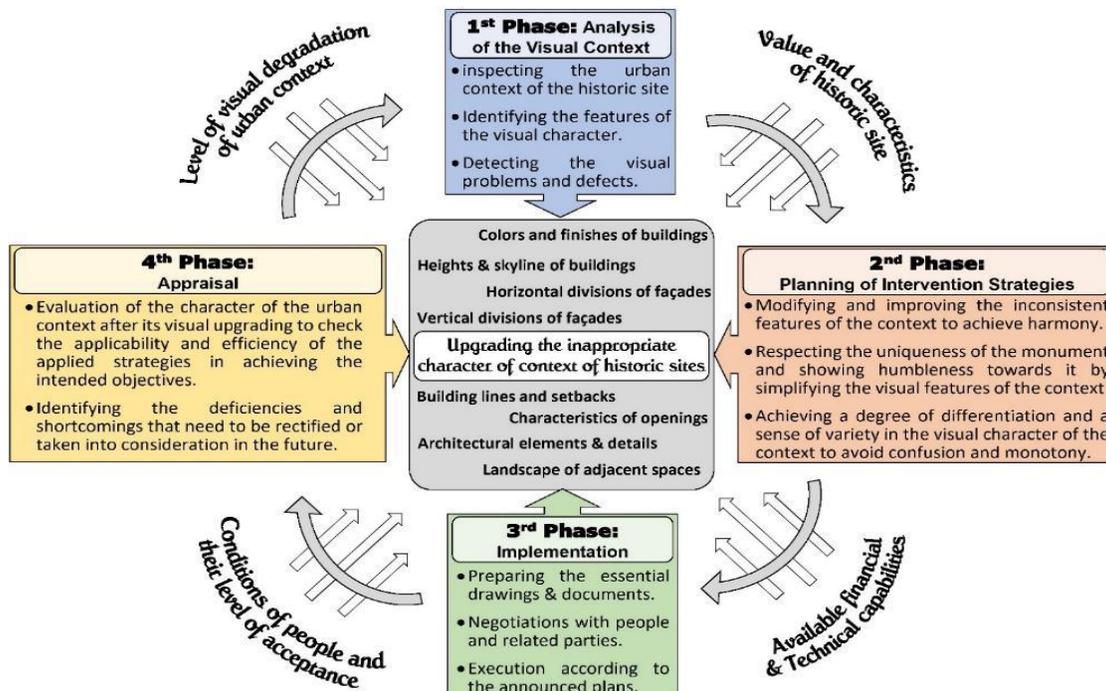
Fig. 1. The proposed framework for upgrading the visual character of building façades adjacent to historic sites (The Authors)

These general recommendations could be considered the most suitable approach to upgrade the inappropriate visual character of unplanned urban districts in Egypt, because it could improve the deteriorated appearance of existing buildings without the need to totally demolish them. Thus, according to these steps as well as the rules discussed above, a general framework can be derived to indicate the procedure required for upgrading the degraded character of such areas. It consists of four main phases and four influencing factors as illustrated in Fig. 1:

- *The first phase:* The aim of this phase is to investigate and analyze the visual character of the urban context of the historic site to extract its prevalent visual features and indicate the visual problems and defects that detract from its homogeneity and compatibility with the monument.
- *The second phase:* The objective of this phase is to suggest the appropriate solutions and strategies of intervention that could be used to get rid of these defects and upgrade the visual character of the place. This could be carried out by modifying, replacing and improving its inconsistent visual features to achieve harmony between incompatible façades at the level of heights, colors, materials, horizontal

and vertical divisions, openings, setbacks, projections and recesses as well as landscape elements. It is recommended to choose the type of alterations that respect the uniqueness of the monument and, at the same time, show humbleness towards it by simplifying the visual features of the context to avoid drawing attention from the monument or competing visually with it. Moreover, a degree of differentiation between the urban background and the historic site is needed to avoid causing any confusion that could detract from its distinctiveness due to its close similarity with the adjacent buildings. Furthermore, adding a sense of variety in the features of the context could help to avoid the monotony that may result from the excessive repetition of the same features throughout all façades.

- *The third phase:* After suggestion and discussion of intervention strategies that should be applied to the context, the essential drawings & documents should be prepared and introduced to the competent authorities and also to the people living or working within the context of the monument to get their approval. This may require several negotiations to convince the concerned parties of the importance and benefits of these suggestions as well as the expected consequences of the intended measures. After obtaining the necessary approvals, execution should be carried out according to the announced plans.

- *The fourth phase:* The aim of this phase is to assess the character of the visual context after its upgrading to evaluate the applicability and efficiency of the applied strategies in achieving the intended objectives. This appraisal helps to identify the deficiencies and shortcomings that need to be rectified in the future or taken into consideration in other development plans.

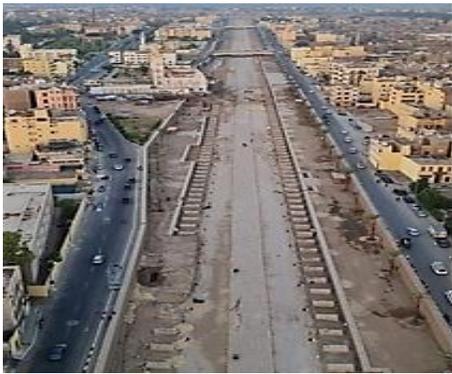
Fig. 6. The avenue of Sphinxes after uncovered [20]

The former governor of Luxor, Major General Samir Farag was the first to activate the idea of uncovering the whole avenue to convert it into an open museum, when he succeeded in passing an official decree in 2005 to remove all the buildings that were standing above the avenue and moving the residents to other places after compensating them [31]. However, due to the political and civil unrest after the protests of 2011 the project was halted until it continued again in 2018 by President Abdul-Fattah al-Sisi. Hundreds of buildings including mosques and a church were removed to the width of 76 meters. After the demolition, a lot of historic remains have been discovered, bringing the total number of the statues to more than 1200 sphinxes [29], some of which are complete, others are broken, and many have only the bases (Figs. 5, 6).

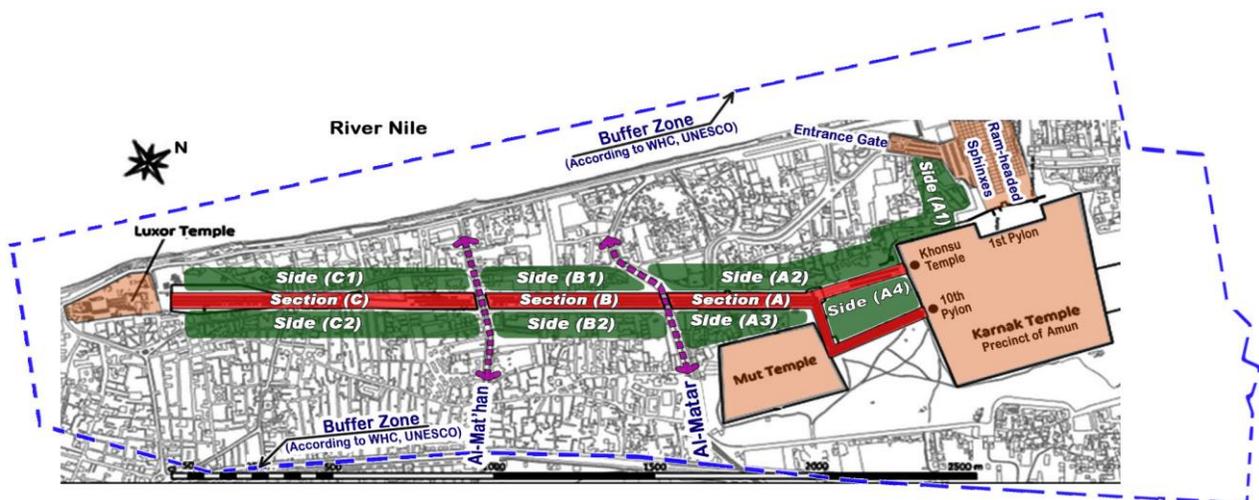
Fig. 7. Map showing the different sections of Sphinxes Avenue connecting Karnak and Luxor temples as well as the boundaries of the buffer zone assigned around the archaeological sites of the area (adapted from Egyptian Antiquities Information System 2008, Egyptian Survey Authority 2012)

Accordingly, a visual analysis of the building façades adjacent to the avenue is needed to determine their detracting features and develop the appropriate scenarios to modify or alter them in order to upgrade their character. To perform this analysis the avenue was divided by the two bridges into three sections including eight sides on the eastern and western flanks of the avenue as illustrated in (Fig. 7). Several field tours were conducted in June 2021 to investigate and survey the urban and visual characteristics of each section, as follows:

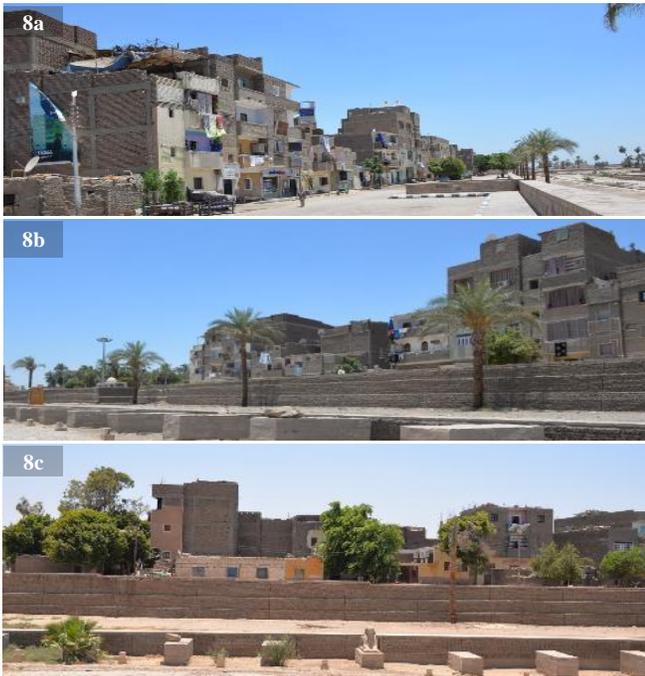
Figs. 8a, b, c and d: The buildings at different sides of section "A" of Sphinxes Avenue (Photo credit: Authors)

- **Section "A":** This section is located at the northern part of the avenue between Karnak Temple and "Al-Matar" bridge. It was divided into four sides: The first side "A1" starts from the entrance gate of the parking area of Karnak temple and extends parallel to its front plaza as well as the Sphinxes Alley leading to the first pylon of the temple. This alley is different from the Sphinxes Avenue connecting Karnak and Luxor temples, as it extends towards the Nile River and its ram-headed statues are in a good condition. The second side "A2" is located on the west and starts from the gate of Khonsu Temple at the southwestern corner of Karnak Temple and ends at "Al-Matar" bridge. The statues in front of Khonsu Temple were ram-headed but they lost most of their heads (Fig. 3). At the middle of this section the avenue branches into two directions: one extends to the east towards Mut Temple and the other continues to the south. The statues of this part are human-headed and many of them have only the bases. The third side "A3" is separated from the fourth side "A4" by the branch of the avenue that heads to Mut Temple. Except for side "A4" which was totally demolished, the urban character of this section in general was considered deteriorated, due to the inhomogeneous, dissonant and modest appearance of buildings. Most of these buildings were informal with unfinished façades and varying heights. Some of them were found dilapidated, partially demolished or incomplete (Figs. 8a to 8c).

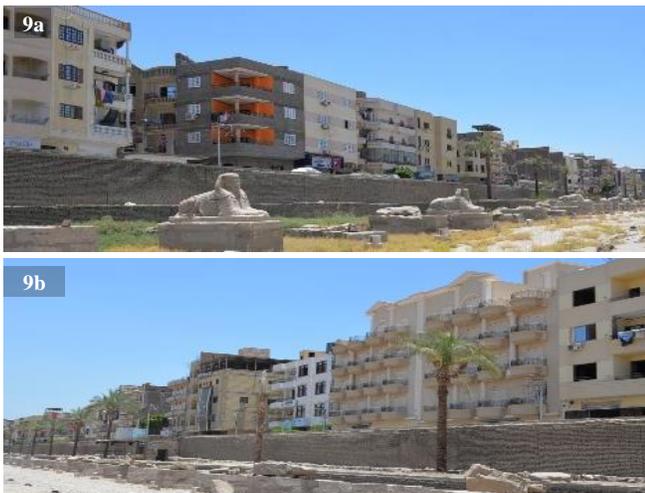
Figs. 9a and b: The buildings at the two sides of section "B" (Authors)

- **Section "B"**: This section is located in the middle of the avenue between "Al-Matar" bridge to the north and "Al-Mat'han" bridge to the south. The buildings of its two sides are newer and more regular compared to section "A". They have similar heights (about four stories on average) but forms, colors and materials of their façades were found dissimilar (Figs. 9a and 9b).

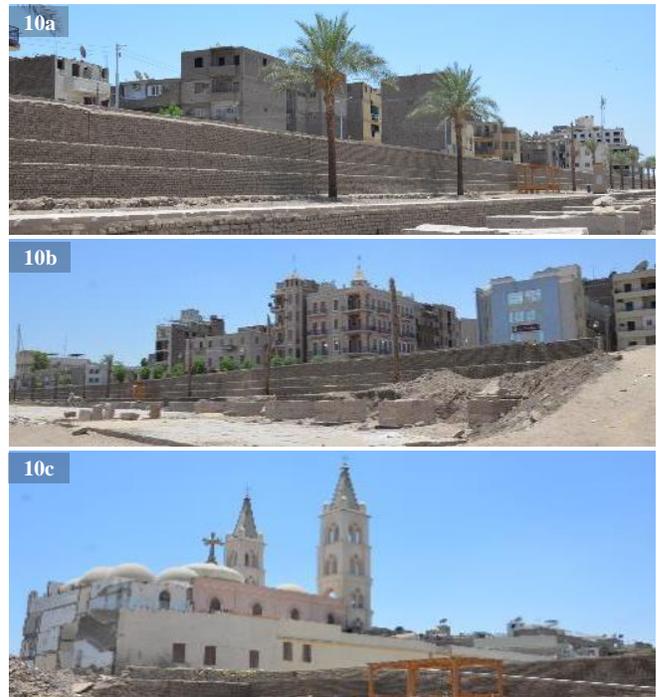
Figs. 10a, b and c: The buildings at the two sides of section "C" of the avenue (Photo credit: Authors)

- **Section "C"**: This section is located at the southern part of the avenue. It starts from "Al-Mat'han" bridge to the front plaza of Luxor Temple. During the field tours it was detected that the urban character of its two sides was varied. Some parts had modest buildings with unfinished exteriors (Figs. 10a), while other parts had newer buildings but with varying colors, heights and finishing materials (Fig. 10b). The most prominent building in this section is the Church of

St. Mary (Fig. 10c) which is characterized by its domes and towers. Although it was partially overlapping with the avenue it was not demolished because it is considered a building of architectural value. Only the adjacent informal buildings were removed.

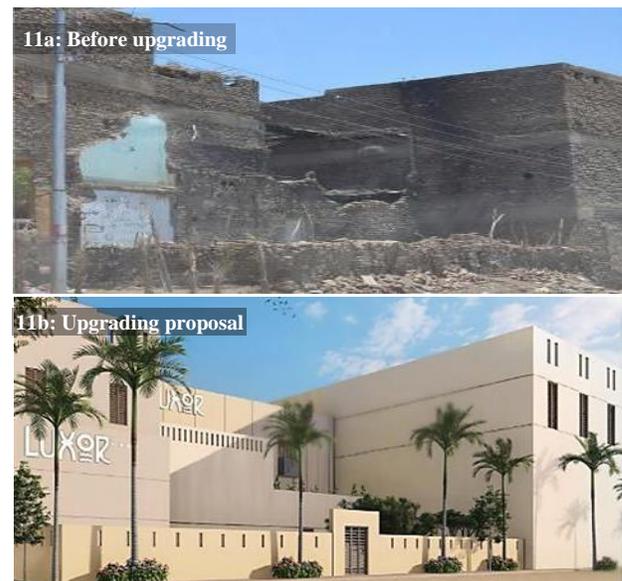
Fig. 11a and b. A proposal to upgrade the visual character of decayed façades by completing, straightening, plastering and painting of unfinished walls. (Authors)

- *Finishes and colors*: Plastering and painting of unfinished façades is a necessary measure to replace the unpleasant appearance of visible bricks and concrete. Moreover, unifying colors of inhomogeneous exteriors could achieve harmony between them and ensures the simplicity of collective façades. After several discussions with the responsible authorities, it was decided to choose the light yellowish beige color for façade finishes because it matches with the color of stones used in ancient Egyptian temples and statues and at the same time it achieves a degree of differentiation from them because of its lighter tone (Figs. 11b, 12b and 13b).

- *Heights:* It is difficult to unify the heights of all buildings due to structural, economic or social reasons. Therefore, adjusting the rhythm of change in heights to make the skyline more regular could be enough. To achieve this, it is necessary to raise the heights of parapets in some buildings using light weight bricks and constructing new walls between the columns of incomplete upper floors in some other buildings (Fig. 15a and 15b). Adding horizontal stripes in the finishing of façades could improve the rhythm of horizontal divisions (Figs. 11b, 12b & 13b).

- *Widths:* Adjusting the rhythm of building widths or façade bays requires demolishing and rebuilding them again, which is not acceptable. Instead, straightening irregular surfaces and uneven edges of poorly built walls by adjusting plaster thickness could reduce the feeling of disharmony and dissonance (Figs. 11a, 11b, 12a and 12b). Besides, adding openings at equal distances in the parapets of buildings could contribute to improving the rhythm of vertical divisions (Figs. 11a, 11b, 15a, 15b, 16a and 16b).

- *Building lines and setbacks:* Differences in setbacks could be reduced by adding high fences in front of recessed façades on the same line of projected buildings and converting the spaces in-between into small gardens to increase the regularity of building lines (Fig. 11a,b & 16a,b).

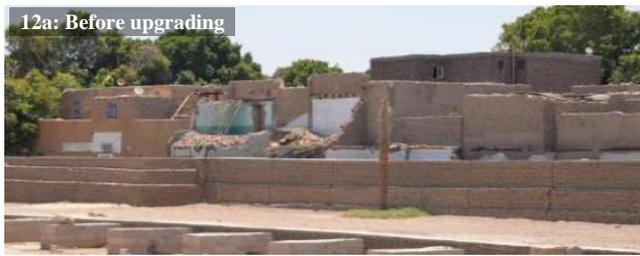
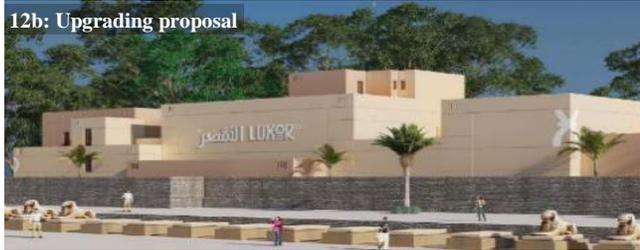
Fig. 12a and 12b. Removing crumbling walls and completing missing parts then plastering and painting of façades using unified colors (Source: Authors)

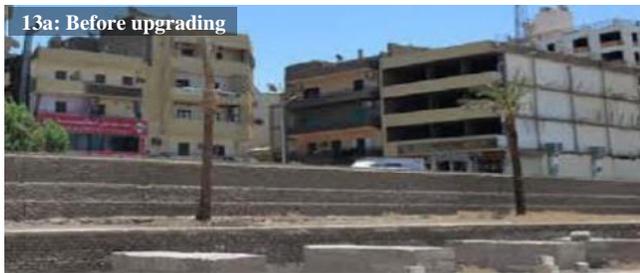
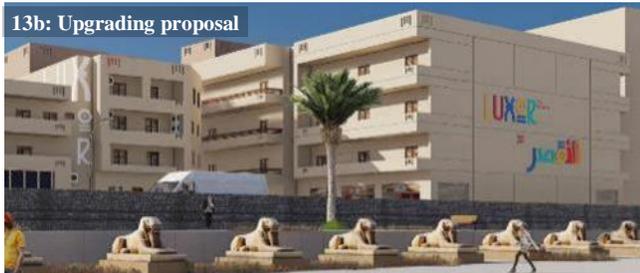
Fig. 13 a and 13 b. Removing the traces of the partial demolition of the front bays in some buildings and completing the missing parts (Source: Authors)

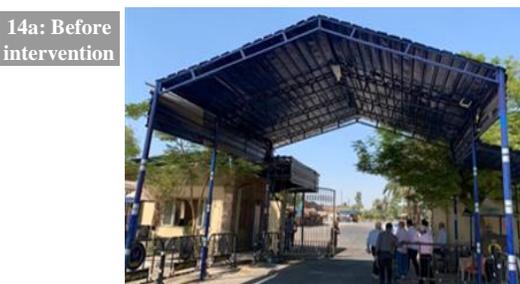
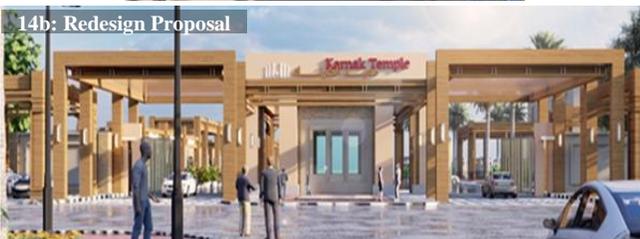
Fig. 14a and 14b. Removing the inappropriate canopy covering the entrance gate of parking area and suggesting a new design for it (Source: Authors)

- *Decayed and incomplete parts*: Upgrading the visual character of façades requires the removal of dilapidated walls and remaining debris left over after demolition works, then building incomplete parts of walls and parapets as well as repairing the irregular walls to make their surfaces more straight with perpendicular edges and corners, either by changing the thickness of plaster layers or by rebuilding them again if necessary. Proposals were prepared to apply the suggested solutions to some representative cases of deteriorated façades (Figs. 11a, 11b, 12a, 12b, 13a and 13b). Also, removing the inappropriate metal shade covering the entrance gate of the parking area of Karnak Temple and preparing a new design for this gate could enhance the overall image of this important spot (Fig. 14a and b).

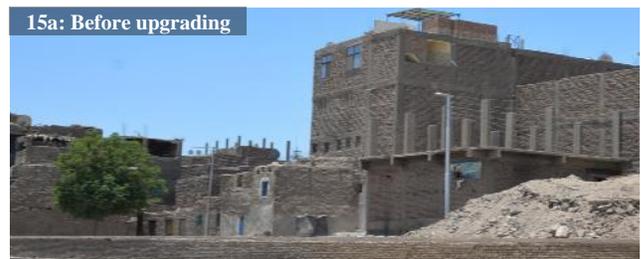
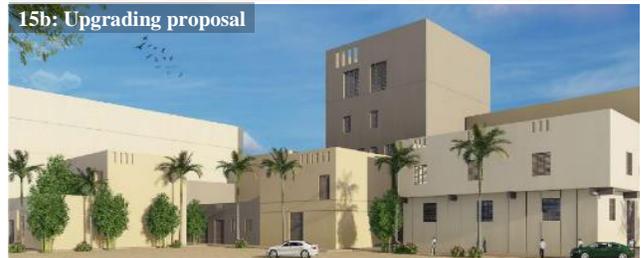
Fig. 15a and 15b. Adjusting skyline by raising heights of parapets and constructing walls between columns of incomplete upper floors. (Authors)

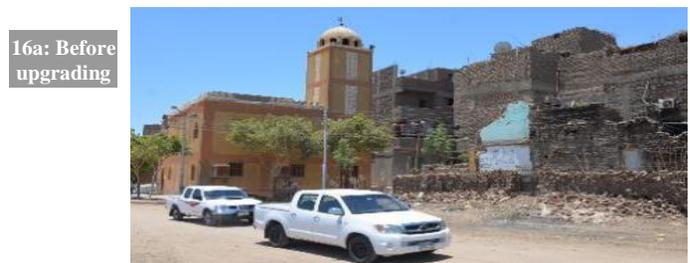
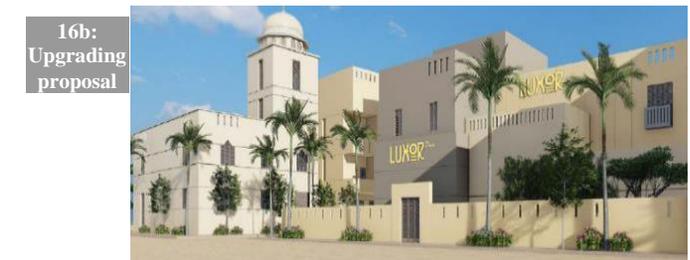
Fig. 16a and 16b. Improving the character of façades by adding openings and stripes at regular rhythms. (Source: Authors)

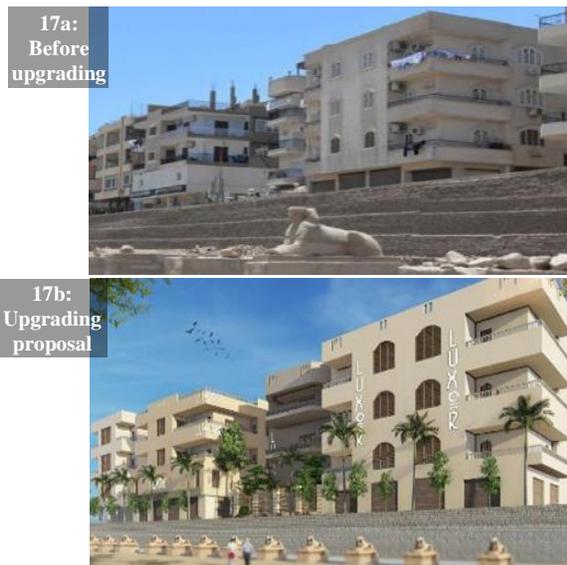
Fig. 17a and 17b. Improving the character by emphasizing the color of openings and planting trees. (Source: Authors)

- *Openings:* Windows and doors of informal buildings need to be emphasized to accentuate their aesthetic role in façades. This could be achieved by painting them in another color different from walls, such as dark beige or brown (Fig. 17a and 17b). Moreover, it is possible to improve the rhythm of openings in façades by modifying their shapes, sizes and disposition. This could be attained by expanding some openings and narrowing others to adjust their sizes. Also, blocking up some windows and reopening them in other positions could help to rearrange their distribution and improve their order. However, these interventions are difficult and not easily accepted by residents. In this regard, adding horizontal stripes to the façades could reduce the irregularity of openings.

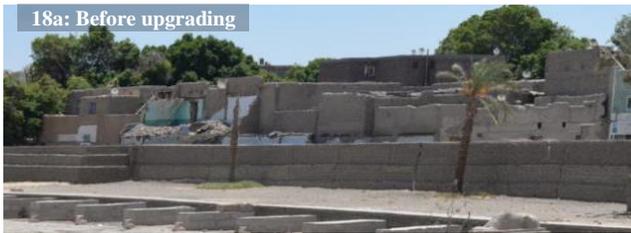
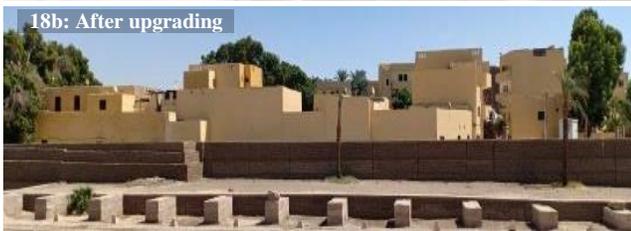
Fig. 18a and 18b. Removing crumbling walls as well as plastering and painting of unfinished façades (Sources: Authors)

- *Decayed and incomplete parts:* The remaining parts and crumbling walls left over after demolition works were totally removed (Fig. 18a and 18b). The uneven surfaces of walls were straightened in finishing phase to make them more regular (Fig. 19a and 19b), and most of the missing parapets of upper roofs were built (Fig. 20a and 20b). A new gate for the parking area of Karnak Temple was constructed according to the proposed design (Fig. 14b and 21). Some walls were also built to infill the gaps between columns of

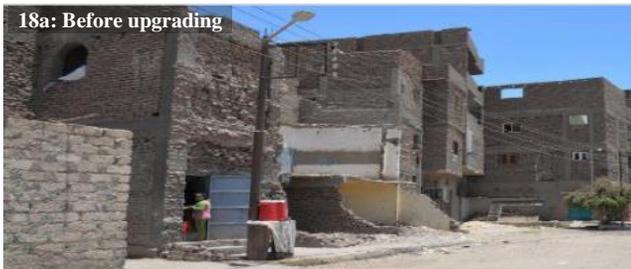
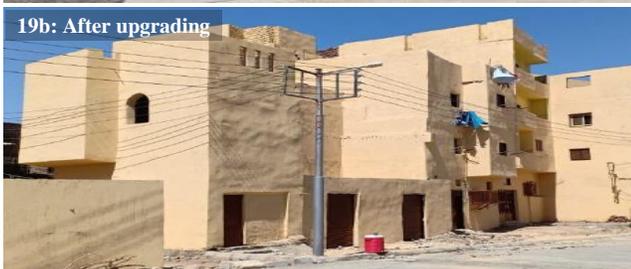
Fig. 19a and 19b. Irregular walls of unfinished façades were straightened in finishing phase (Photo credit: Authors)

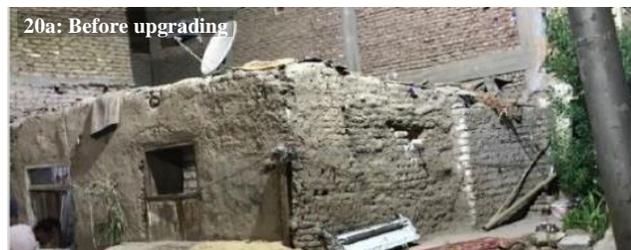
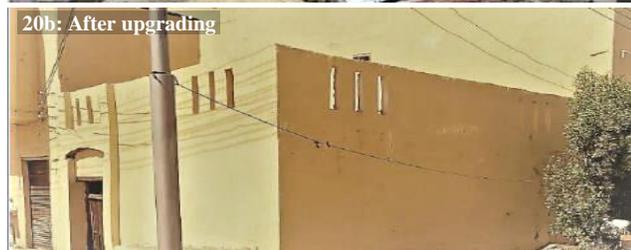
Fig. 20a and 20b. Unfinished walls were plastered and painted, and missing parapets were built (Photo credit: Authors)

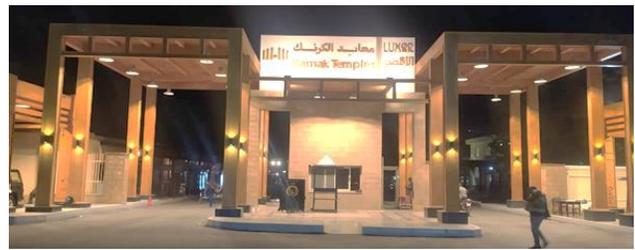
Fig. 21. The new gate to Karnak parking lot after execution

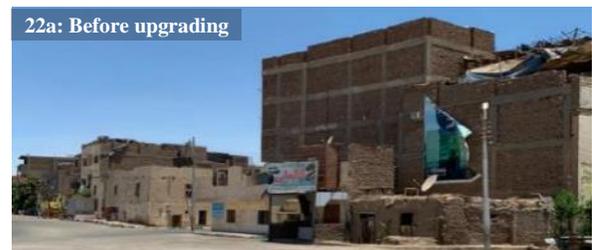
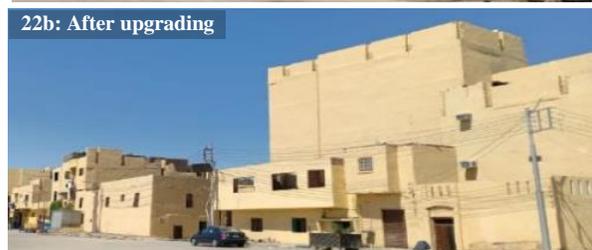
Fig. 22a and 22b. Plastering and painting of unfinished façades to replace their previously rough and dark appearance. (Photo credit: Authors)

- *Finishes and colors:* Unfinished façades were plastered and painted to get rid of their previously rough and dusty appearance. Also, most of the other buildings were repainted again using unified colors (Figs. 18a to 20b and 22a to 25). This helped to achieve a great deal of harmony between inhomogeneous buildings. Some well-finished and distinctive buildings were left without modifying their colors, and this added a sense of variety and reduced monotony in the appearance of collective façades.

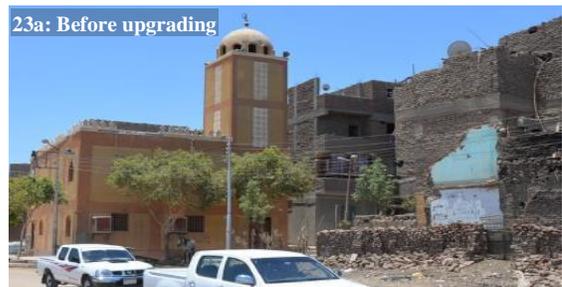
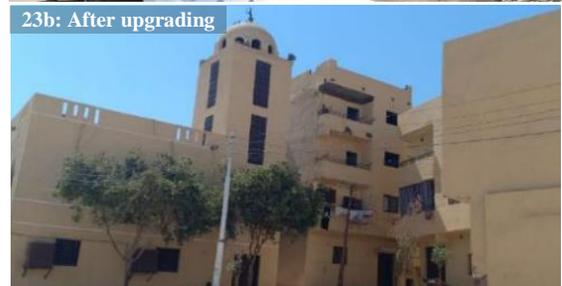
Fig. 23a and 23b. Building new parapets and walls to complete the missing parts (Photo credit: Authors)

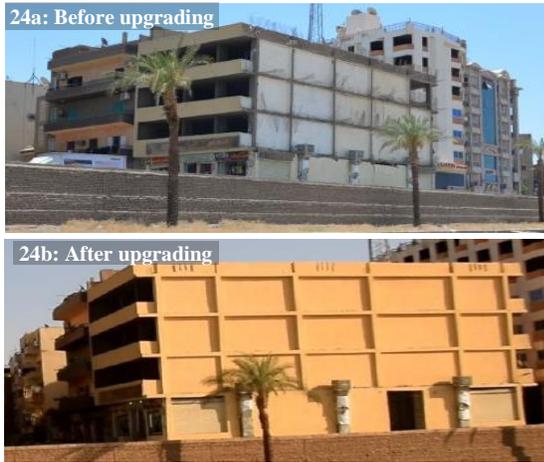
Fig. 24a and 24b. Finishing of the remaining parts of partially demolished buildings (Authors)

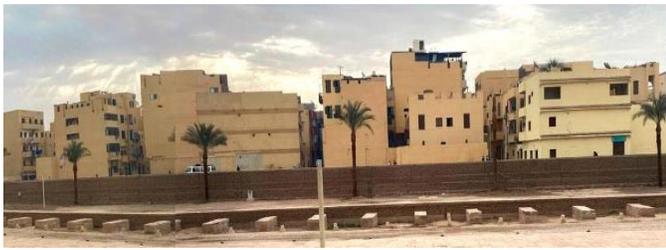
Fig. 25. Repainting and finishing of buildings using unified colours. (Authors)

- *Heights:* Completing the missing parts of parapets and walls of upper floors in some buildings helped to improve the rhythm of change in heights and reduced the irregularity of skylines to some degree (Fig. 25 and 26). Nevertheless, it was hard and highly expensive to adjust the heights of all buildings. On the other hand, adding horizontal stripes in dark colors to the façades of some buildings helped to improve the rhythm of horizontal divisions (Fig. 25 and 27).

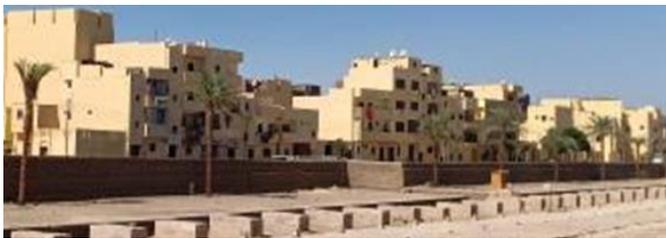
Fig. 26. Reducing the irregularity of skylines by raising parapets and building walls to complete upper floors (Photo credit: Authors)

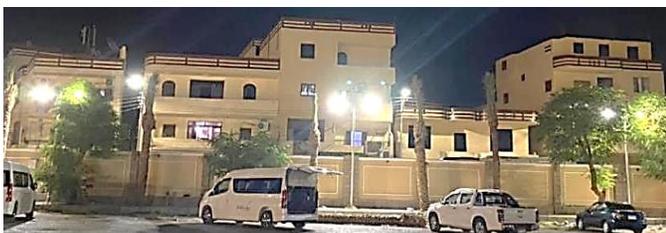
Fig. 27. Using dark colored bands to emphasize the upper edges of buildings

rhythm of horizontal divisions (Fig. 27 and 28), but not to the desired level because of the difficulty to adjust the widths of existing buildings without removing and rebuilding them again at regular distances.

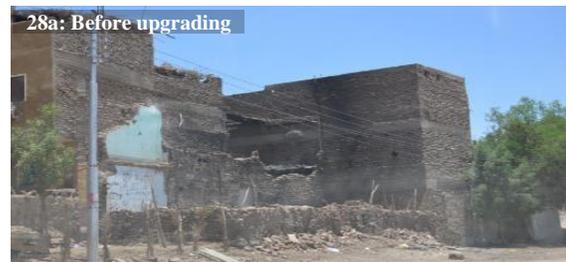
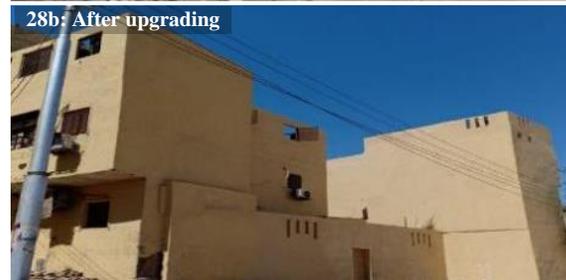
Fig. 28. Enhancing the visual character and rhythms (Photo credit: Authors)

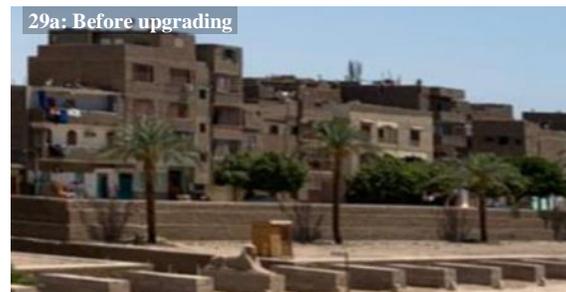
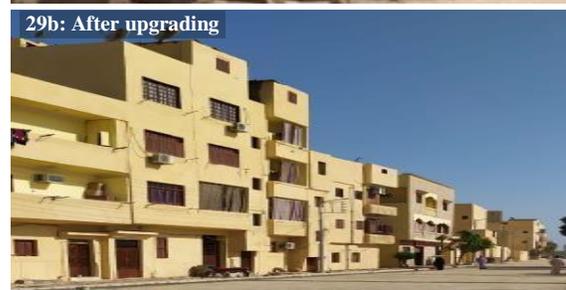
Fig. 29. Emphasizing the visual role of openings in façades (Authors)

- *Openings:* Windows and doors were almost obscured and dimmed due to the gloomy and dusty appearance of unfinished buildings. Painting them in dark colors different from walls helped to emphasize their visual role and improved the rhythm of façades (Fig. 29a and 29b). Some adjustments were also made to their shapes, sizes and disposition but not on a large scale due to financial and social difficulties.
- *Building lines and setbacks:* The retaining walls on both sides of the avenue played an important role in hiding the irregularity of building lines (Fig. 25 and 26). Some walls were built in front of recessed façades to increase the degree of regularity, but still not enough to achieve the desired level of homogeneity.

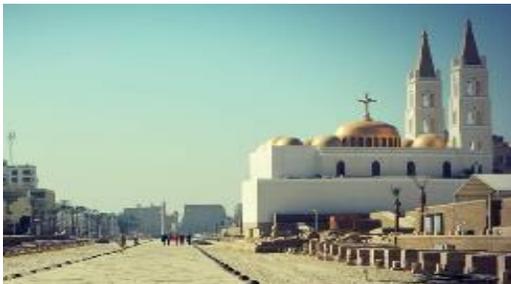
Fig. 30. St. Mary Church after renovation

- *Architectural elements and details:* Using similar finishes and colors in building exteriors and the removal of visual pollution factors helped to simplify and reduce the negative effect of inconsistent and chaotic details of collective façades. The regular openings of parapets and the horizontal stripes of façades also increased the sense of homogeneity. Moreover, the distinct buildings, such as St. Mary Church, were renovated in different colors to highlight their visual role as local landmarks (Fig. 30).

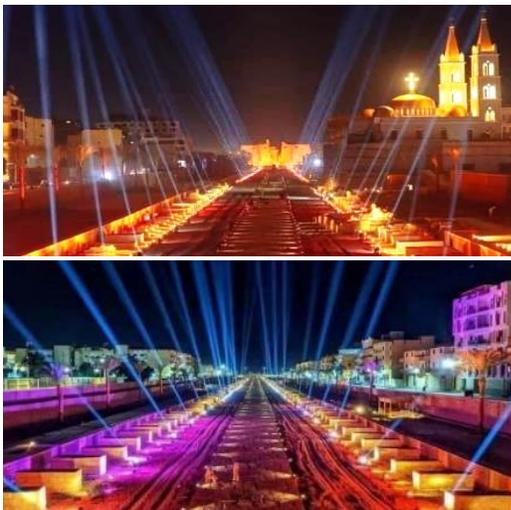
Fig. 31 and 32. Illumination of the Sphinxes Avenue at night [5]

- *Landscape of adjacent spaces:* Several palms and trees were planted at regular distances along the sides of the avenue, but they are still not enough. The streets and spaces in front of buildings were paved, but still lack sufficient seats and lampposts. Special lighting units were installed to illuminate the sphinxes and accentuate their distinctive features at night. These lightings played an effective role in the opening ceremony of the avenue on 25 November 2021 (Fig. 31 and 32).
